# **Phase I Environmental Site Assessment Report**

65 East Cottage Street  
Boston, Massachusetts

**Boston DND**  
September 2014

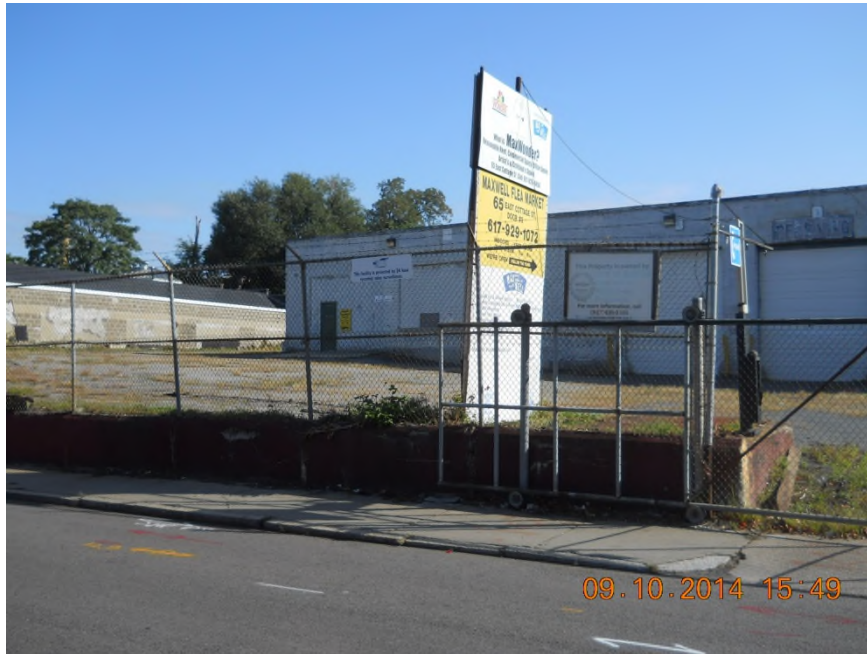
Photo Number: 1

Description: Subject Property

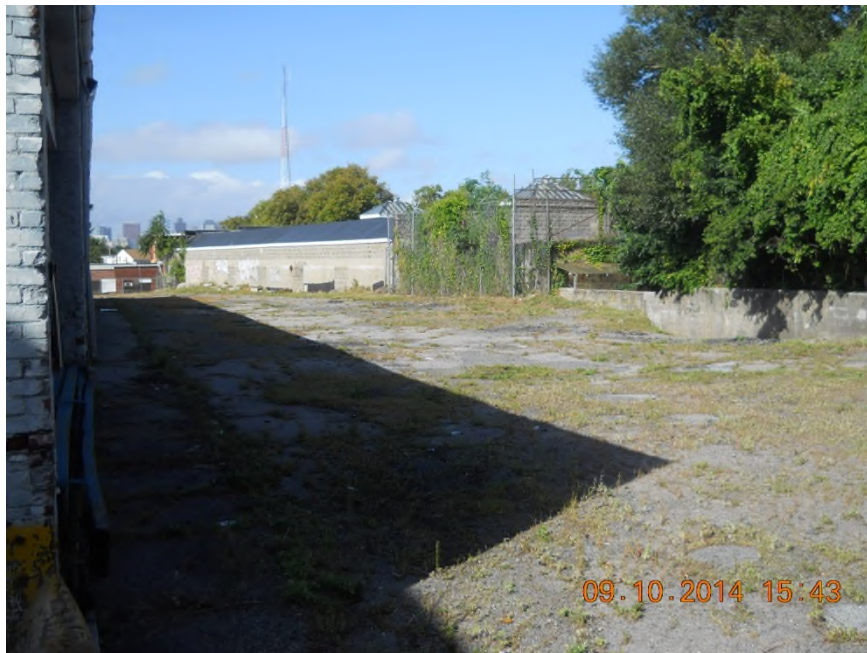
Photo Number: 2

Description: Subject Property – eastern portion

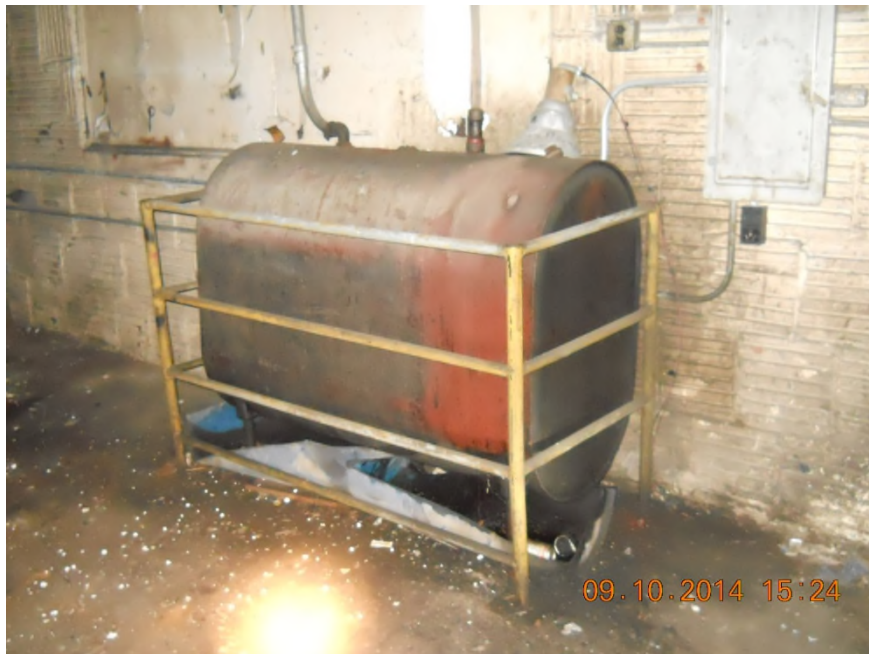
Photo Number: 3

One current AST (estimated 300 gallons in size) was observed within the building at the subject property. A secondary containment structure (consisting of a blue plastic drum split in half) beneath the AST contained a small quantity (estimated less than five gallons) of oil at the time of the site reconnaissance.

Description: AST
